BLANDFORD UNPAVED ROADS DRAFT REPORT

Evaluation and Forecast of Roadway Conditions and Maintenance Requirements

June 2023

prepared by the
Pioneer Valley Planning Commission

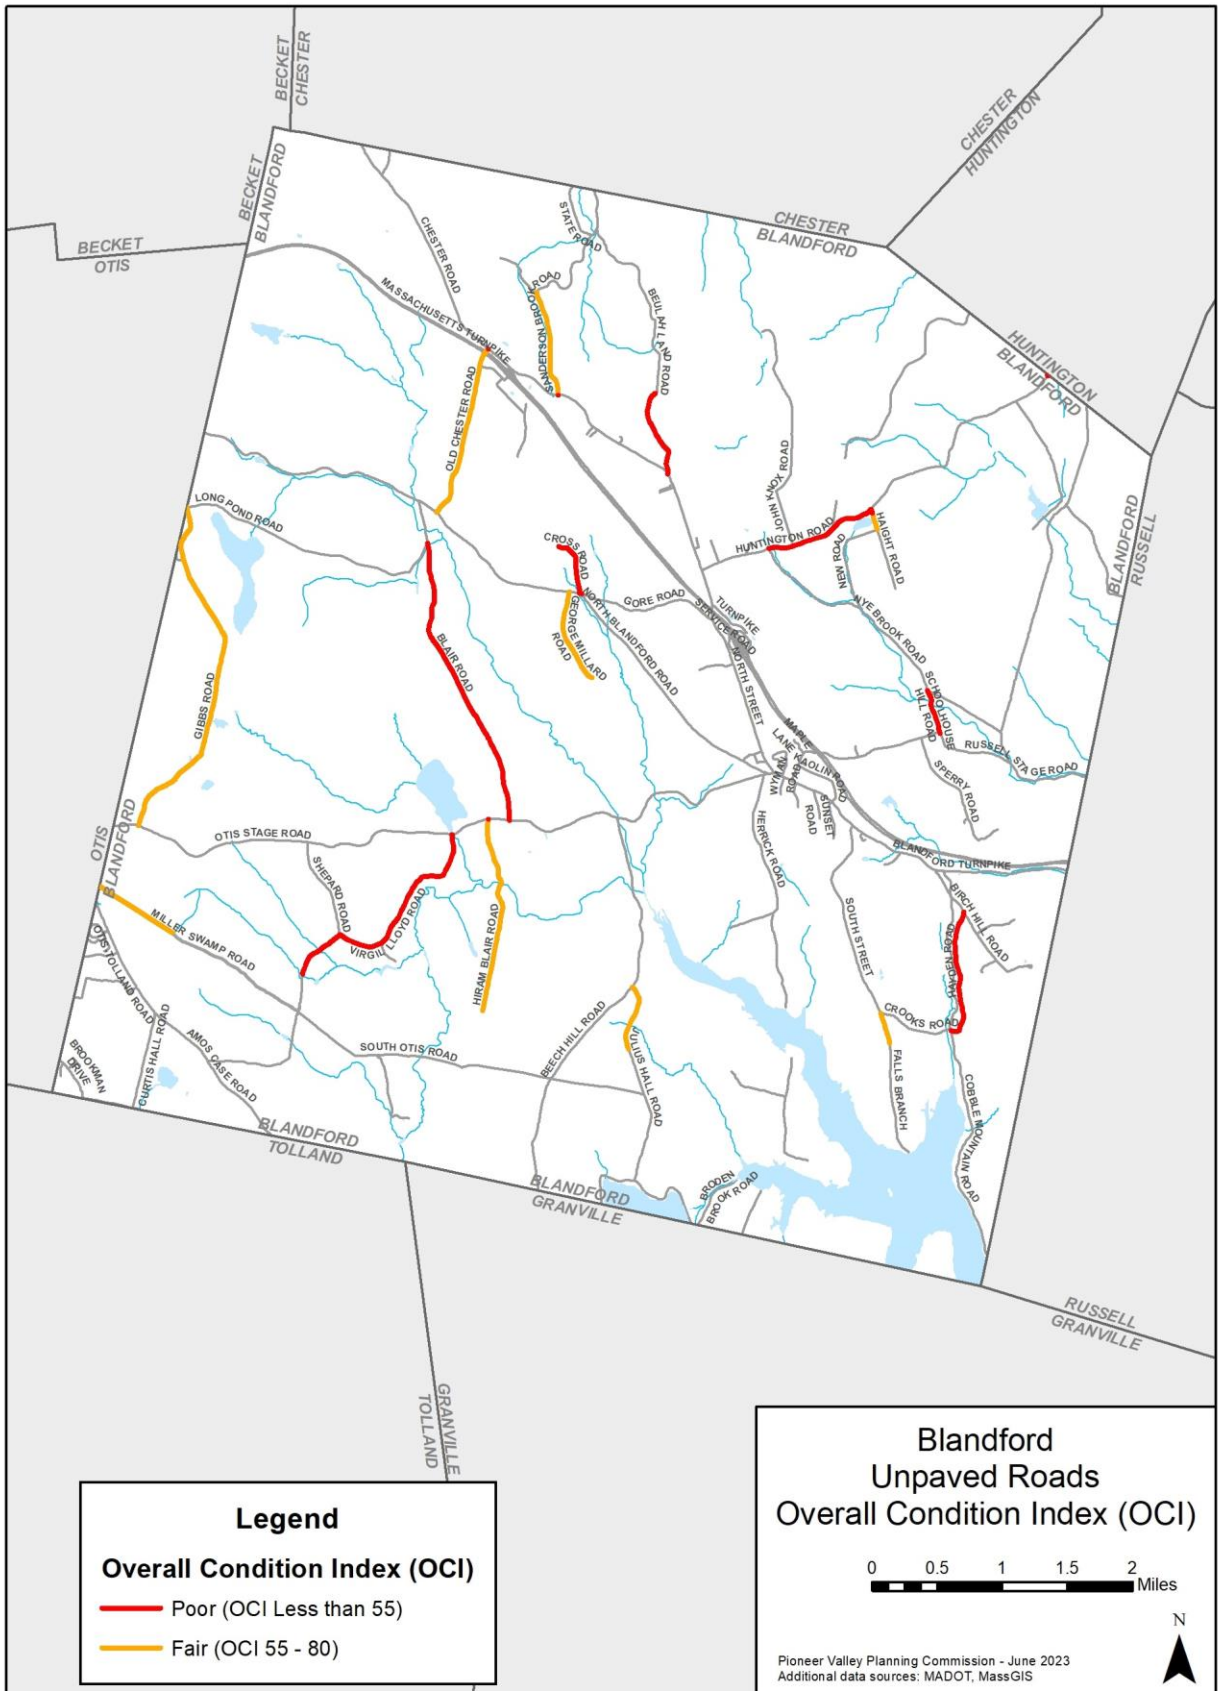
Figure 1 – Existing Overall Condition Index for Unpaved Roadways

The PVPC staff surveyed 14.4 miles of unpaved roadways, which constitute 19 roadway segments. This assessment relied on both a windshield survey as well as in-field measurements to evaluate roads based on seven distress criteria such as potholes, distortions, rutting, corrugations, dust, roadside/cross slope drainage, and loose aggregate. The average OCI for the spring of 2023 was rated at 59, which indicates that the roadways are, on average, in fair to poor condition.

Table 2 reflects a listing of the existing condition of the rated roadway segments. These segments are also shown on Figure 1. Please note, existing weather events after the date of the field survey may have resulted in additional deterioration of all unpaved roadways. Gibbs and Huntington Road appear as 2 segments in Table 2 consistent with the Massachusetts Roadway Inventory File.

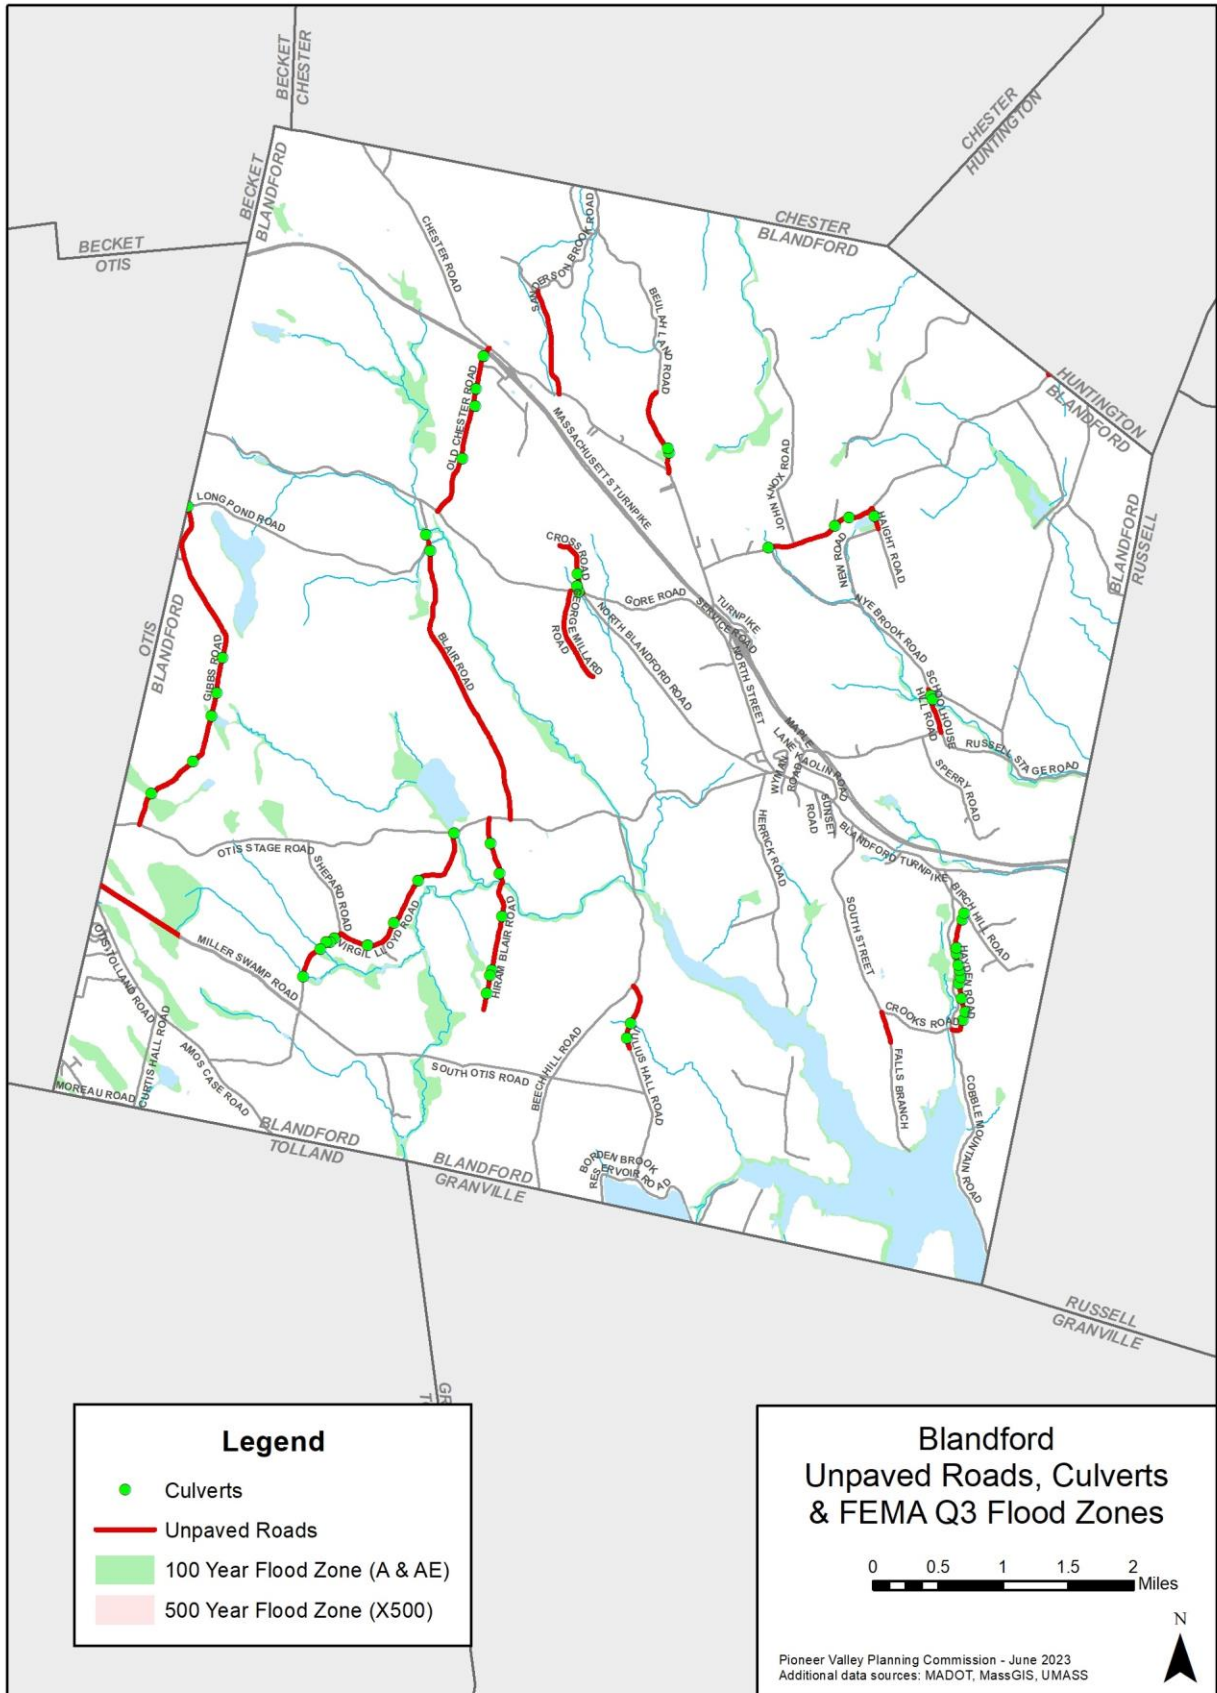
Figure 2 Flood Zones and Culverts Map

3. Floodplain – The proximity to the road to the 100 year and 500 year flood zones increases the likelihood of roadway washout during extreme weather events and floods. The 100 and 500 Year Flood Zones in the Town of Blandford are shown on Figure 2.

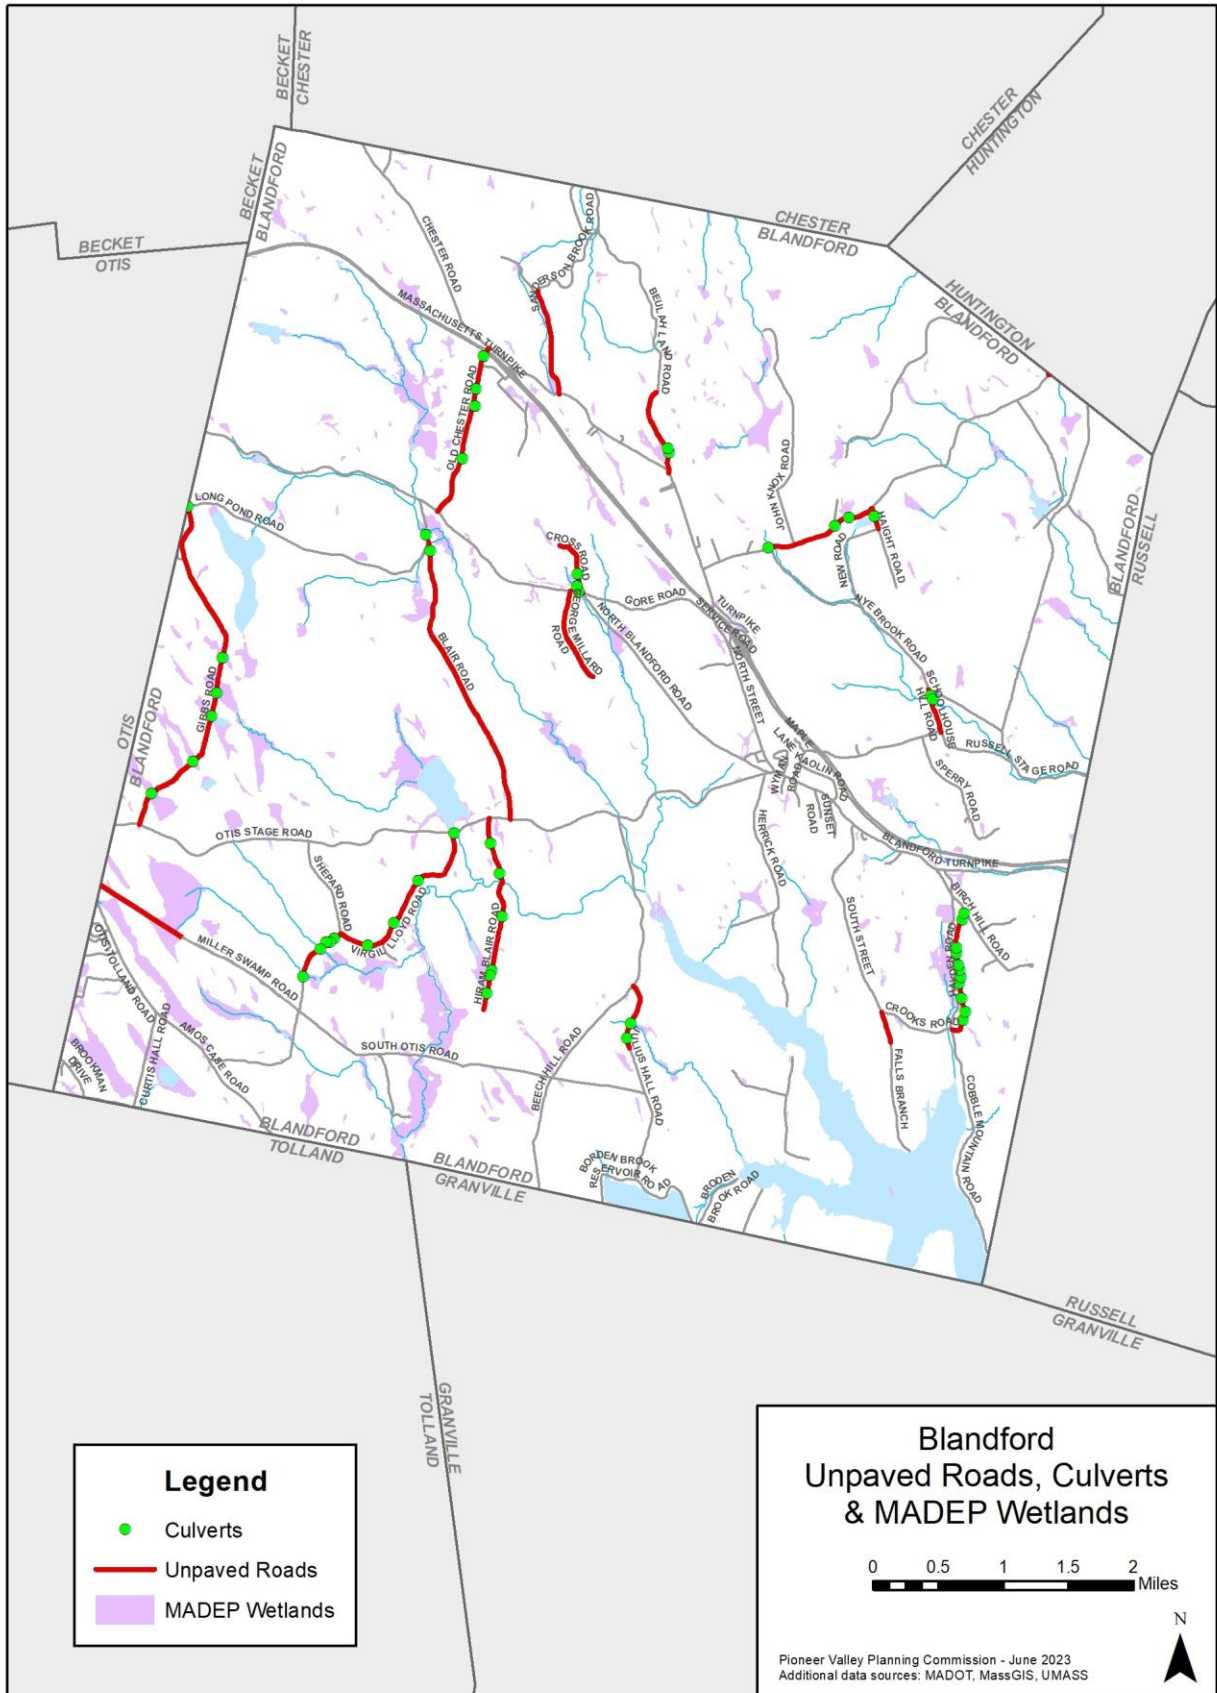
Figure 3 Wetlands and Culverts Map

5. Wetlands – The proximity of a road to existing wetland areas can increase the rate of deterioration. The existing areas of wetlands in the Town of Blandford are shown on Figure 3.

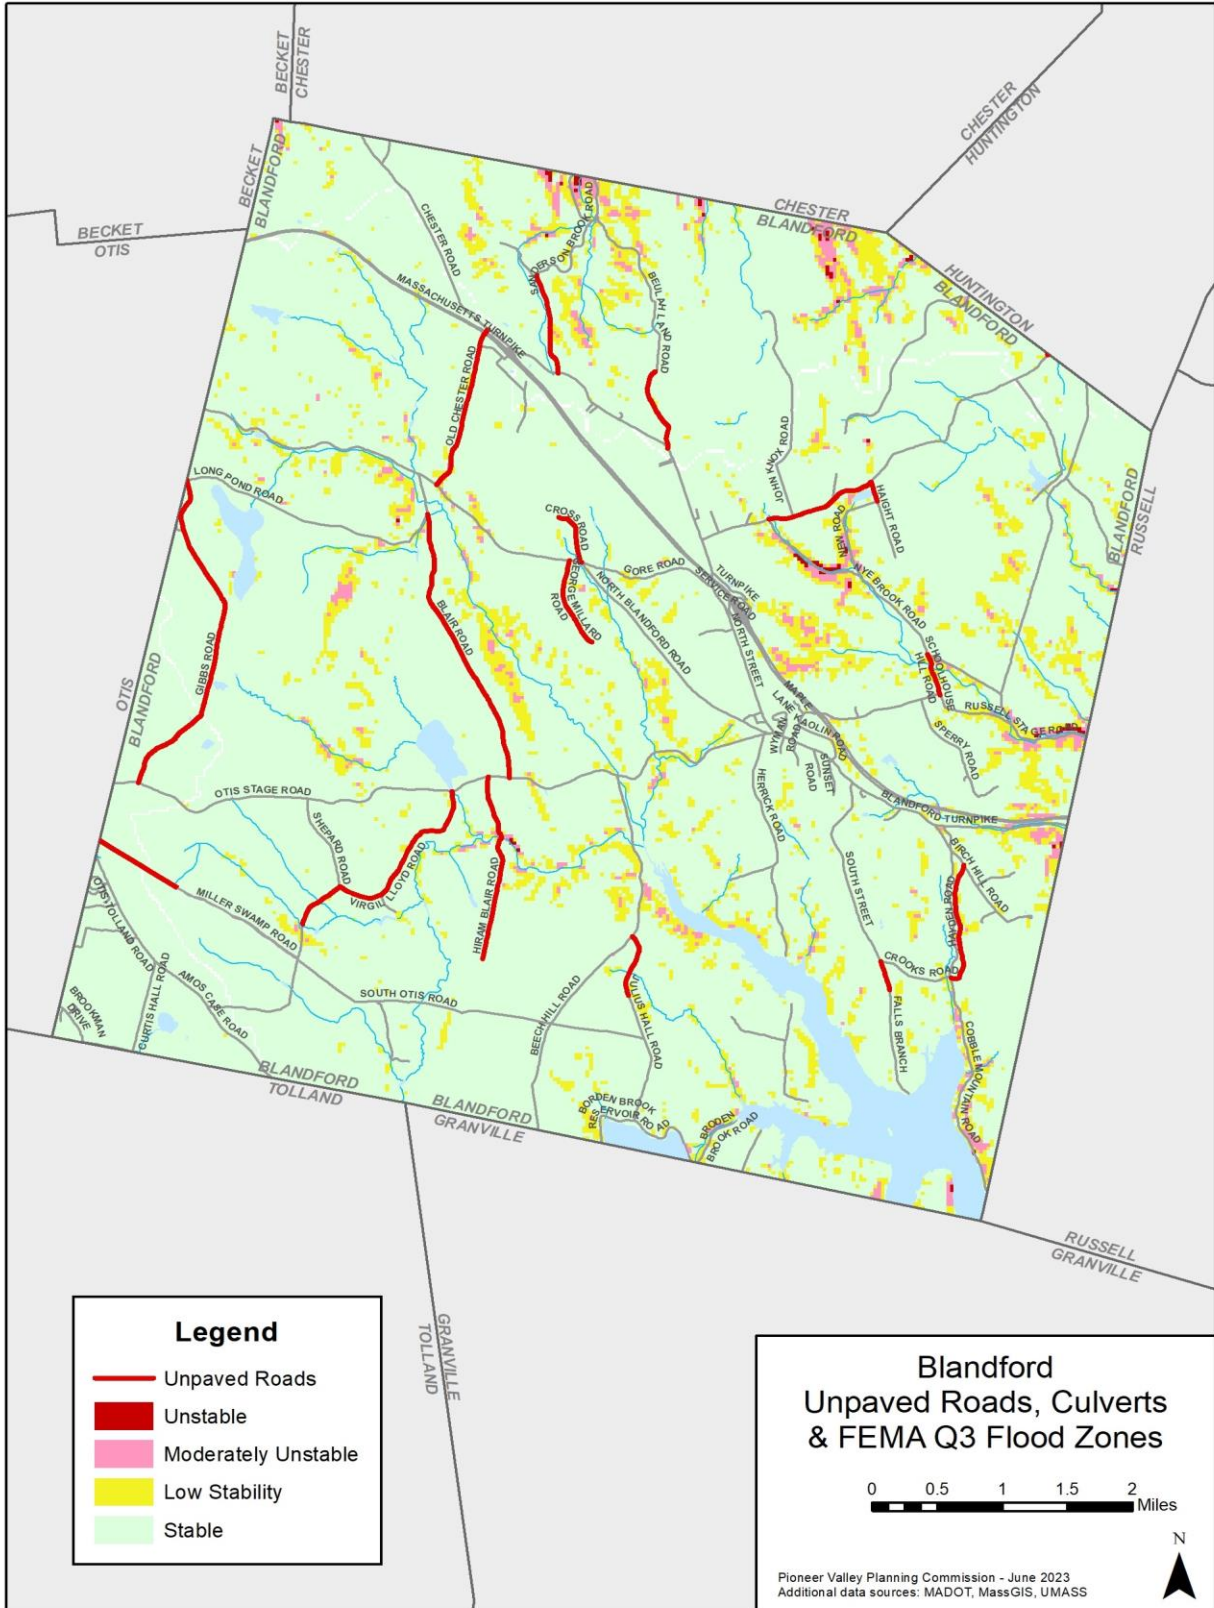
Figure 4 Slope Stability Map

9. Road Surface Shape – The condition of the existing grade or crown on the road that allows water to flow off to the side into roadside drainage.
10. Slope Stability – An indication of the existing stability of the soil in the vicinity of the road. Less stable areas are more prone to erosion and washout. This information is based on the Massachusetts Geological Survey Slope Stability Map. <http://mgs.geo.umass.edu/biblio/slope-stability-map-massachusetts>. Areas of unstable slope in the Town of Blandford are shown on Figure 4.
